# **Resilience of Critical Infrastructure to Extreme Fires – Gaps and Challenges**

Prepared by:  
Hossein Mostafaei  
Ahmed Kashef  
Mohamed Sultan  
Cameron McCartney  
Patrice Leroux  
National Research Council

Contract Report  
DRDC-RDDC-2014-C66  
April 2014

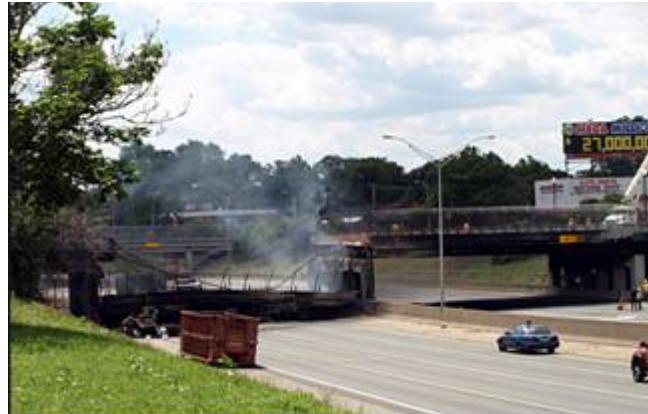
*Figure 1: Collapse of the overpass bridge on I-75 due to tanker fire.*

- Structural Response: The bridge deck consists of a concrete deck and steel girders. No information was found describing the collapse mechanism of the overpass bridge. The fire was completely extinguished by 4:00 a.m. However, the bridge collapsed 30 minutes after the large deflagration. It is not clear whether loss of strength in the steel of the main girders initiated the collapse or if it was the thermal expansion of the deck and the girders which resulted in a structural buckling and failure. Currently the bridge design standards do not include requirements to avoid premature collapse due to a fire scenario.

- Fire Load: Compared to incidents described earlier in this report, the fire load created in this incident is relatively high. The tanker truck carried 13,000 gal of fuel (likely gasoline). Since the fire was exactly under the overpass, a large fire load was imposed on the bridge, resulting in structural failure. A report also indicated involvement of another truck, a tractor-trailer carrying produce.

- Explosion/BLEVE: An explosion was reported by the media after the tanker lost 9000 gal of its fuel. However, no official report or information was found to indicate a possibility of BLEVE in this incident.

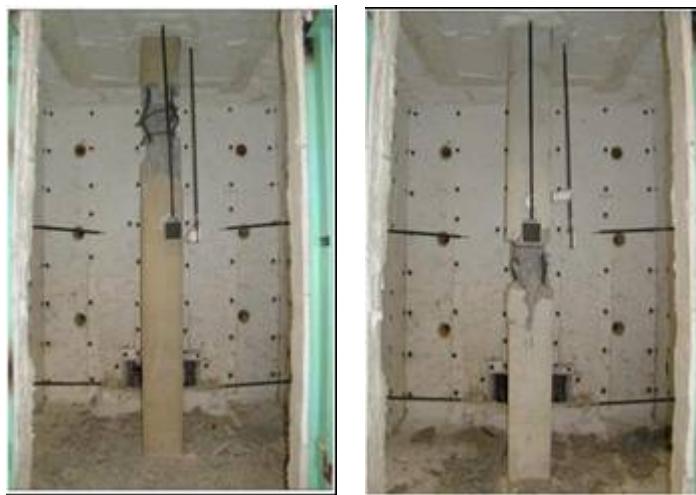
*Figure 11. The two column specimens after testing for failure loads; column tested for E1529 on the left and column tested for E119 on the right.*

- Large spalling (a vertical shear failure) occurred for the specimen tested based on E119 a few minutes after the start of the fire. This could be due to higher moisture content of this specimen, however, further studies needed to investigate such failure.
- In both tests, temperatures in the centre of the column cross-section continued to increase for up to about 2 to 3 hours after the stop of the fire. It took several hours (18 to 20 hours) for the concrete to come back to the ambient temperature.
- In both tests, the columns could carry only up to about 40% of their original load capacity, almost the same failure load, after the fire exposure. A higher failure load was expected for the E119 test. This could be due to the initial large spalling of the E119 test specimen.
- Spalling was also observed a few minutes after the start of the ASTM E1259 test.

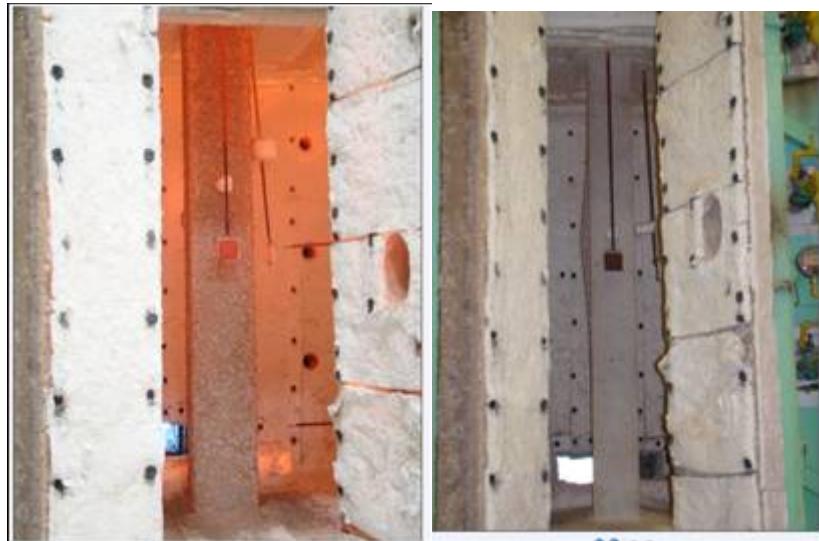
Figure 17 illustrates the column specimens after the fire test stopped and the furnace door was opened. Figure 18 illustrates the spalling patterns on the cross section of the two specimens around the final load failure locations. Based on the remaining cross section area the residual concrete strengths after fire, compared to their original strengths were calculated. Results: the residual concrete load capacity for the E1259 specimen was 46% of its original capacity and the E119 specimen was 50% of its original capacity.

*Figure 17. Column Specimens just after shutting down the burners of the furnace; E1529 test on the left and E119 test on the right.*
